Annual Inspection Report Gragg-Wade Field Airport

# **ANNUAL INSPECTION REPORT**

NOVEMBER 5, 2010

CHILTON COUNTY (GRAGG-WADE FIELD) AIRPORT CLANTON, ALABAMA

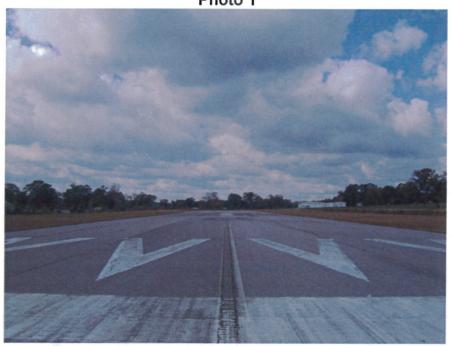
- Runway 8 The Approach/Departure Path is obstructed by trees, a power pole and a hangar.
- → Runway 8 The runway is displaced 819 feet. The displaced Approach/Departure Path is unobstructed.
- → Runway 26 The Approach/Departure Path is obstructed by trees and rising terrain.
- → The FAA Runway Protection Zone is penetrated by trees and rising terrain on Runway 8 and by trees on Runway 26.

Runway 8 approach from the displaced threshold

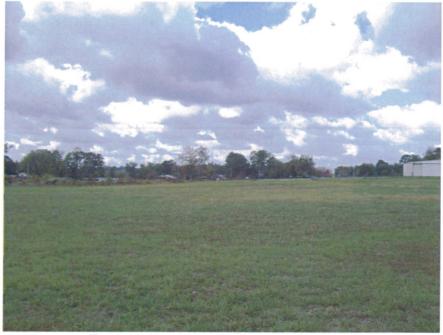
Photo 2

Runway 8 approach from runway end

→ In order to meet certain FAA grant assurances the obstructions located within the area of the FAA RPZs for runway 8 and 26 should be cleared.

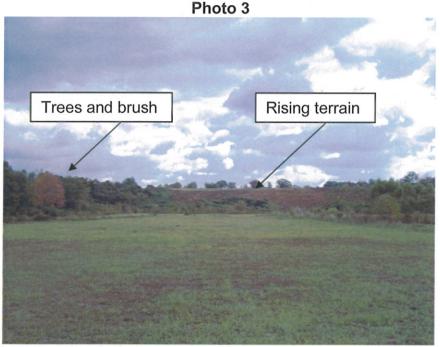
Approach to Runway 26 from runway end which is obstructed by a line of trees and brush along the north edge of the Approach/Departure Path and the rise in terrain across the approach.

- → In order to meet state licensing requirements, obstructions to runway 26 ALDOT Approach/Departure Path must be removed or the threshold displaced or relocated to provide an unobstructed 20:1 approach slope.
- → See Appendices 2 and 3.

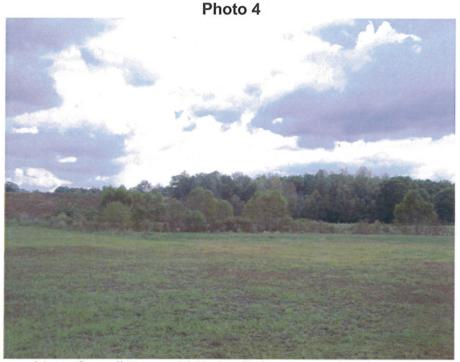
→ The Runway Safety Area is violated by a group of small trees growing 175 feet from the runway end. This line of trees begins 79 feet from the centerline and extends 143 feet to the south of the centerline.

Line of small trees within the Safety Area of Runway 26

- Remove all obstructions to the required Safety Area.
- → To meet FAA requirements all obstructions must be removed within an area beginning at the threshold and extending 300 feet with a width of 150 feet centered along the extended runway centerline.

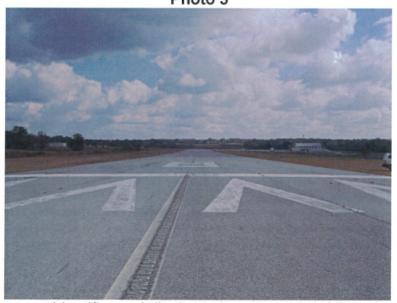
- → The Runway Identifier Markings of Runway 8 are in FAIR condition
- → The Runway Identifier Markings of Runway 26 are in POOR condition.
- → The runway centerline markings are in POOR condition.

Runway Identifier and displacement chevrons of Runway 8

→ The runway should be remarked in accordance with FAA AC 150/5340-1J.

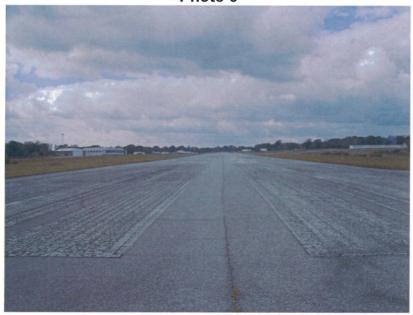
Photo 6

Runway Identifier markings of Runway 26

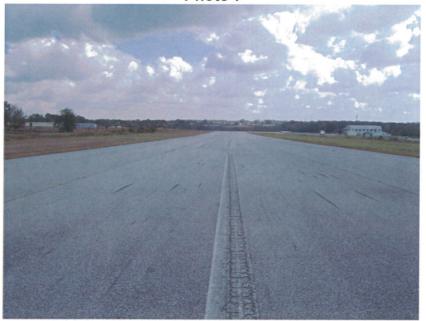
Runway centerline markings

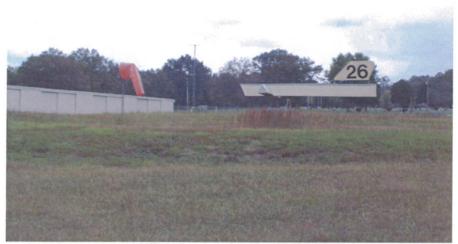
#### Photo 8

- → The windsock and tetrahedron are operational.
- → The windsock is lighted.

Windsock and Tetrahedron

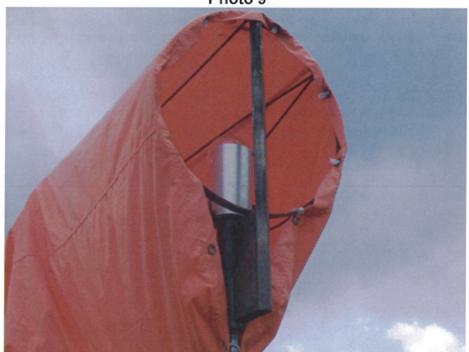
#### Photo 9

Lighted windsock

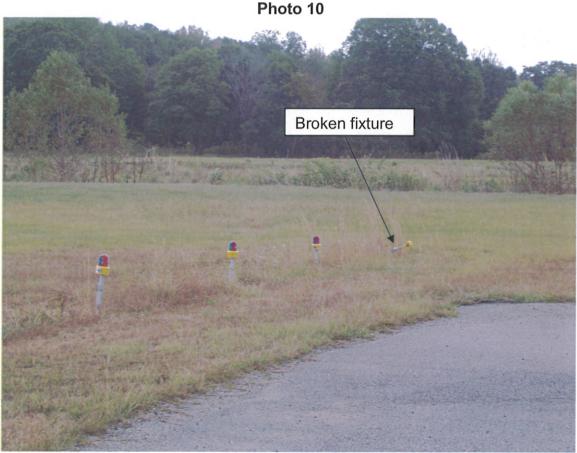
- → The airport lighting system meets licensing requirements.
- → One red light has a broken mount on Runway 8 at the runway end.
- → One threshold fixture is broken on the Runway 26 threshold.

Runway 26 threshold lighting on the South edge of the runway

> Replace all broken fixtures.

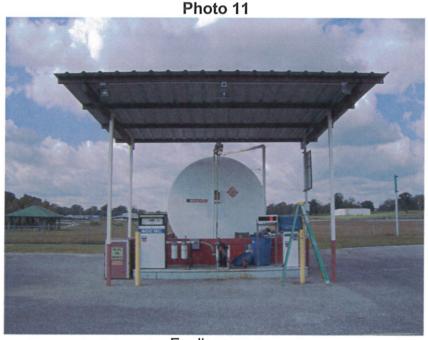
The fueling area meets the requirements established by the Alabama Department of Transportation. However the State of Alabama Department of Agriculture and Industries may have additional requirements for fueling systems that were not considered during this inspection.

Fueling area

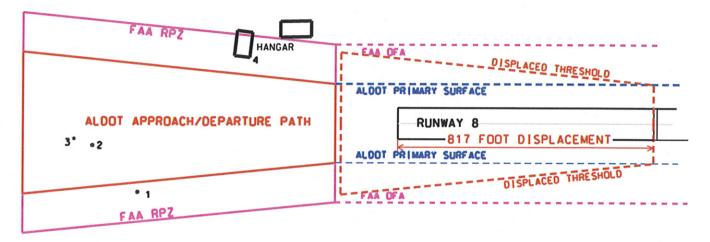
GRAGG-WADE FIELD
CLANTON MUNICIPAL AIRPORT
PLAN AND PROFILE RUNWAY 8
NOVEMBER 5, 2010

VIOLATIONS OF THE ALDOT 20:1 SLOPE:

- 2. +71 FOOT TREE 978 FEET FROM RUNWAY END 71 FEET FROM CENTERLINE 9:1 SLOPE
- 3. +85 FOOT TREE 1037 FEET FROM RUNWAY END 50 FEET FROM CENTERLINE 9:1 SLOPE

VIOLATIONS OF FAA RPZ (20:1 SLOPE)

- 1. +39 FOOT POWER POLE 833 FEET FROM RUNWAY END 219 FEET FROM CENTERLINE 6:1 SLOPE
- 2. +71 FOOT TREE 978 FEET FROM RUNWAY END 71 FEET FROM CENTERLINE 9:1 SLOPE
- 3. +85 FOOT TREE 1037 FEET FROM RUNWAY END 50 FEET FROM CENTERLINE 9:1 SLOPE

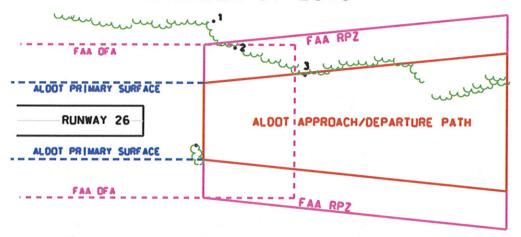
# GRAGG-WADE FIELD CLANTON MUNICIPAL AIRPORT PLAN AND PROFILE RUNWAY 26 NOVEMBER 5, 2010

VIOLATIONS OF 20:1 SLOPE:

A LINE OF TREES THAT INCLUDE

3. +42 FOOT TREE
534 FEET FROM RUNWAY END
152 FEET FROM CENTERLINE
7:1 SLOPE

4. +43 FOOT RISING TERRAIN
1013 TO 1025 FROM RUNWAY END
PERPENDICULAR TO CENTERLINE
19:1 SLOPE

VIOLATIONS OF FAA RPZ (FAR PART 77 34:1 SLOPE)

A LINE OF TREES THAT INCLUDE 2. +49 FOOT TREE 301 FEET FROM RUNWAY END

239 FEET FROM CENTERLINE 2:1 SLOPE

3. +42 FOOT TREE 534 FEET FROM RUNWAY END 152 FEET FROM CENTERLINE 7:1 SLOPE
